HOTEL BOKAN „EXCLUSIV“

EVALUATION CRITERIA

INFORMATION FOR WHEELCHAIR USERS AND PEOPLE WITH REDUCED MOBILITY

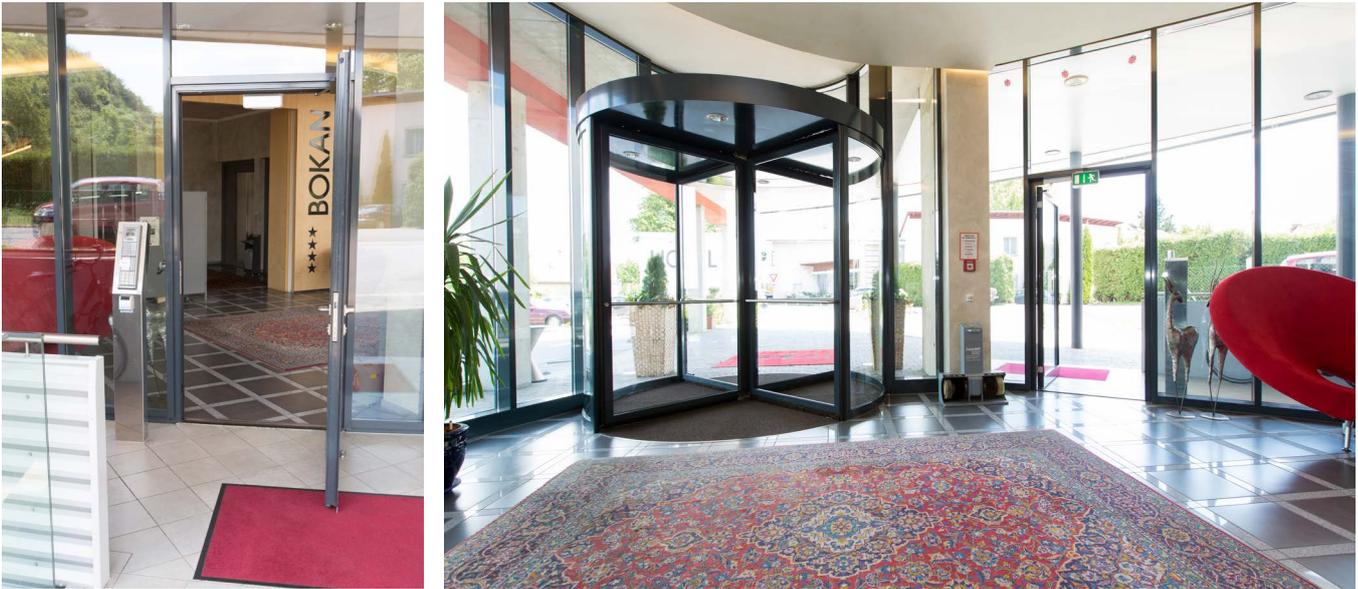
- Access to the hotel is step-free, but **not threshold-free** (thresholds max. 3 cm high)
- Easy to navigate and low vibration, free of obstacles
- Path at least 150 cm wide, max. 100 m long

- Path continuously lit, partially covered
- Maximum longitudinal gradient 6%, maximum transverse gradient 2%
- **The main entrance is not the accessible entrance (carousel revolving door).**

- The accessible entrance is right next to it (easy to find)
- Entrance covered, free of obstacles
- Clear width of entrance door at least 90 cm, one-sided **door threshold max. 3 cm high**

- Door easy to open, **door closer**
- Handrails at standard height (no twist or shell handles)
- Approach area on the opening side of the door at least 200 x 150 cm, on the closing side at least 150 x 120 cm

- On the closing side of the door, there is an approach area of at least 50 cm next to the door handle; **on the opening side, there is no approach area of at least 50 cm**

- Glass door, **insufficiently contrasting markings**
- **Door opening side not marked**
- Doorbell or intercom at standard height
- Grating or dirt-trapping mat easily accessible

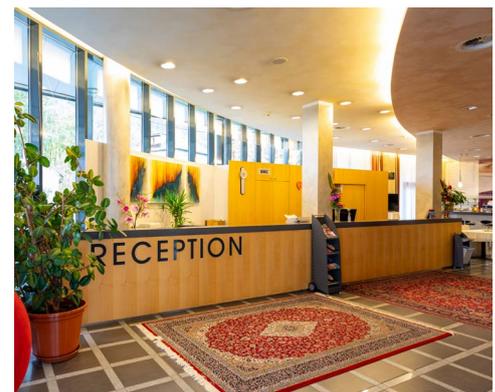
Reception

- Reception/waiting area spacious, completely level, no thresholds
- Seating available (**makes it difficult to stand up**)
- Reception: barrier-free access and use, visual and verbal contact between wheelchair users and reception staff guaranteed
- Movement area of at least 150 x 150 cm in front of the reception desk
- **Counter 115 cm high** (standard max. 85 cm)
- **Reception desk not wheelchair accessible**

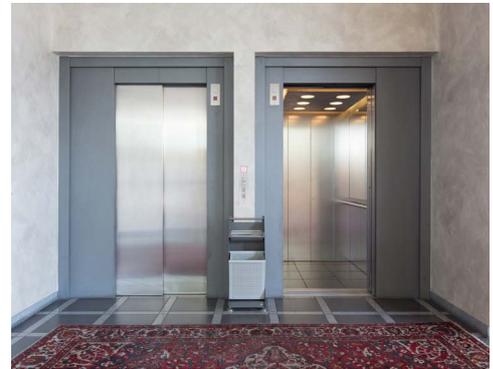
Lift

- Accessible without thresholds
- Movement area in front of entrance and exit at least 150 x 150 cm
- Clear door width at least 90 cm, no door threshold, light barriers at max. 100 cm
- **Lift car size 100 x 140 cm** (standard min. 110 x 140 cm)
- No stairs leading down opposite the shaft door
- Push buttons in the immediate vicinity of the lift door
- Handrail available, at standard height
- **No mirror opposite the lift door**
- Emergency call button available, at standard height
- Position indicator in the lift car at standard height

- **No tactile floor markings**
- Push buttons located in close proximity to the lift door
- **Push buttons not in raised lettering or Braille**
- **Push button for the building exit is not highlighted**
- **Labelling of control buttons too small**
- **Pressing the buttons (inside and outside) is not confirmed audibly**
- **Display on the lift (inside and outside) is not large and easy to read**
- Acoustic signal when lift arrives, **no audible announcement in lift**
- Handrail available

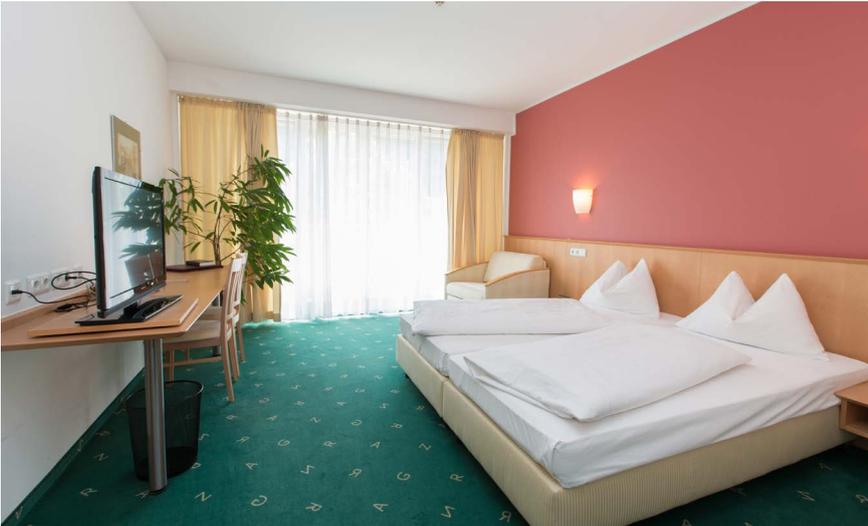
Barrier-free room

- Threshold to the room max. 2.5 cm high
- At least 150 cm of space on one side of the bed
- On the other side of the bed, there is 120 cm of space, which means that the room could be used by two wheelchair users with some restrictions
- **no under bed wheelchair access (box spring bed)**, top edge of bed 45–50 cm
- Light can be switched on from the bed
- Passage widths in the room 110 cm
- Light switch at a height of 85–110 cm
- **Coat hooks at a height of 130 cm** (standard 85–120 cm).
- Short pile carpet easily accessible with a wheelchair
- Movement area in front of the window at least 150 x 150 cm, window handle height max. 110 cm
- Balcony with movement area of at least 150 cm
- Access via 4 cm high threshold
- **No handrail available**
- **Unobstructed view over railing not possible**

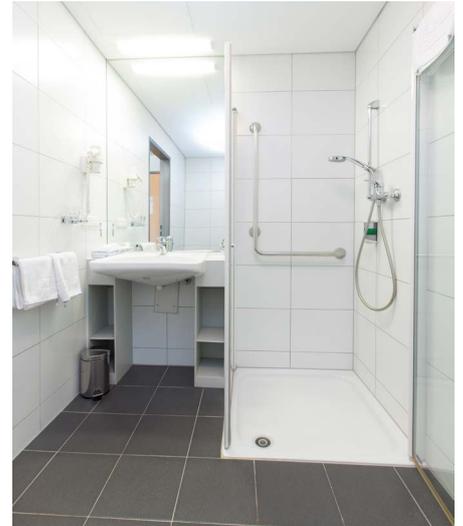
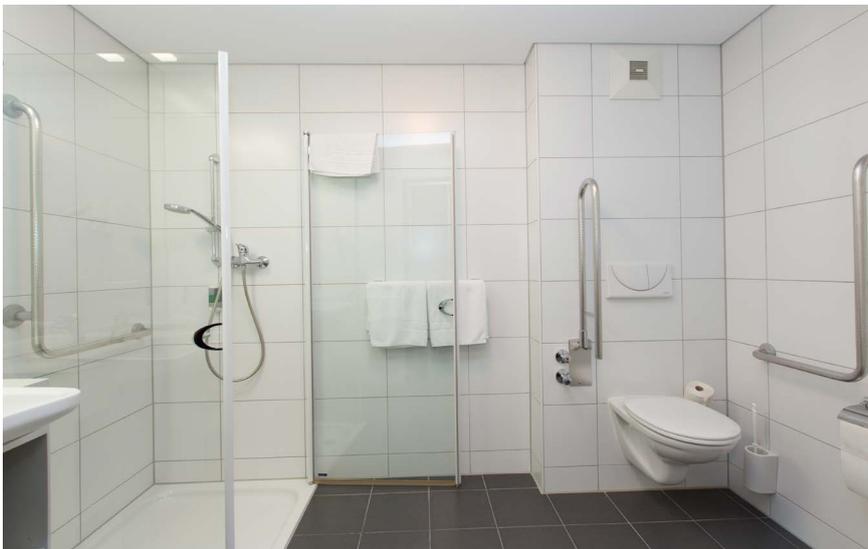
Barrier-free bathroom

- Easy to open, no door closer
- Approach area on the opening side of the door at least 200 cm long, **only 117 cm wide** (standard at least 150 cm)
- Approach area on the closing side of the door at least 150 x 120 cm
- On both sides of the door, there is an approach area of at least 50 cm next to the door handle
- Door handle (no twist, knob or shell handle) at standard height
- **No additional horizontal door pull handle on the closing side of the door**

- Shower area with **4 cm threshold, 90 x 90 cm in size** (standard min. 130 x 180 cm or 150 x 150 cm)
- **Floor not slip-resistant**
- Flexible shower enclosure (fold-away transparent partition, **not marked with high contrast**)

- Vertical grab rail is installed at a distance of 70–85 cm from the corner, reaching a height of at least 150 cm
- **Horizontal grab rail at a height of 92 cm** (standard 75–85 cm), at least 50 cm long on the first wall side (towards the corner), **less than 90 cm long** on the second wall side

- Grab rails must be easy to grip
- Fixed folding shower seat (without folding support handles), seat surface at least 40 x 40 cm in size
- Height-adjustable hose shower, **adjustable height does not comply with the standard** (75–150 cm)

- Shower fitting designed as a single-lever mixer tap, **at a height of 120 cm** (standard 80–110 cm), accessible from the side from a seated position
- **No soap holder available**

- **No emergency bell in the shower area**

- **100 cm space in front of the toilet bowl for manoeuvring** (standard min. 120 cm)
- Accessible from the left, with at least 90 cm of space on the side for manoeuvring

- **Distance between the front edge of the toilet and the rear wall 54 cm** (standard min. 65 cm)
- Toilet height 46–48 cm, **no backrest available**
- Horizontal grab rails on both sides, additional vertical grab rail

- Folded-up grab rail protrudes max. 20 cm into the room
- Folding support handle easy to use and securely attached to the wall
- **Flush not at standard height (80–110 cm), cannot be reached from a seated position on the toilet**

- Toilet paper can be reached while seated on the toilet, **but the roll is not in the folding support handle**
- **No emergency call system available**

- **Movement area in front of the washbasin less than 120 x 120 cm**
- Top edge and depth of washbasin comply with standard
- Clear height under the washbasin at least 70 cm, flat plaster siphon (protected with plastic or porcelain)
- **Not wheelchair accessible over a width of at least 100 cm**
- single-lever tap, distance to the front edge of the washbasin max. 20–35 cm
- Mirror lower edge at a maximum height of 95 cm
- Operating level of fittings at a height of 80–110 cm, **hairdryer at a height of 150 cm**
- Light switches at standard height

- Door handle on bathroom door clearly visible
- Fold-away transparent partition wall in the shower area, **not marked with high contrast**
- **No emergency call button in the bathroom**
- **Fittings in the bathroom do not stand out visually from their surroundings**
- **No audible alarm in the bathroom**
- **Balcony without handrail**

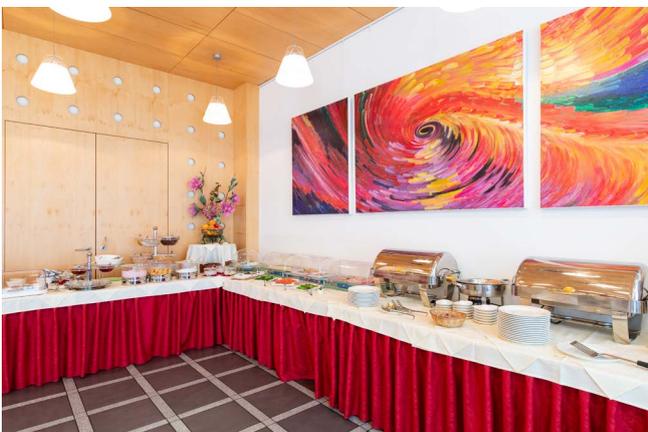
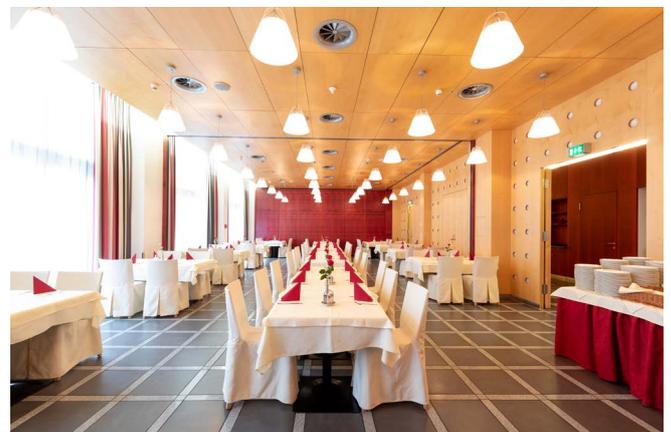
Breakfast room

- Accessible without thresholds
- **No accessible cloakroom available**
- Passage widths of main corridors at least 100 cm, of cross corridors at least 70 cm
- Tables wheelchair accessible (min. 80 cm wide, 70 cm high, 60 cm deep), table height max. 85 cm
- High chairs for kids available
- Seating 46–50 cm high, with sturdy armrests and backrests
- Breakfast buffet
- Clear width of the path next to the buffet at least 120 cm
- Food is within reach at 40–70 cm, food selection at max. 120 cm height
- Drinking straws are available on request
- Outdoor dining area/open space is accessible

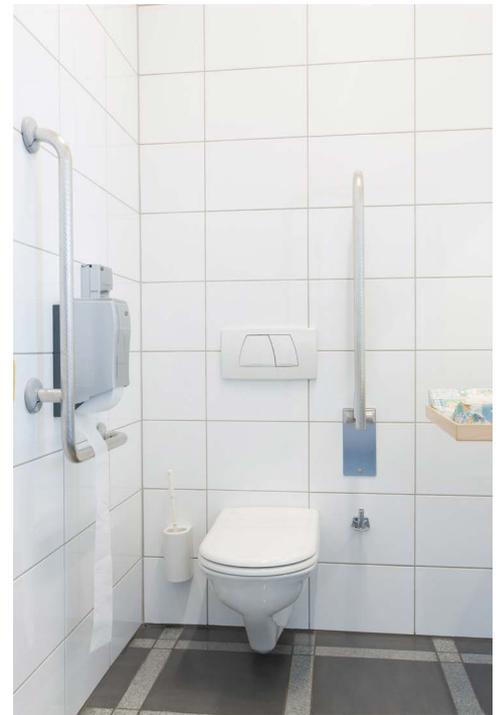
Accessible WC (ground floor)

- accessible without thresholds
- Separately arranged (unisex)
- **No 150 x 150 cm manoeuvring space available in the toilet room**

- Clear door width at least 80 cm, no threshold
- Door opens outwards, can be unlocked from the outside in an emergency
- Easy to open
- Approach area on the opening side at least 200 x 150 cm, **on the closing side less than 150 x 120 cm**
- On the opening side of the door, there is an approach area of at least 50 cm next to the door handle; **on the closing side there isn't**
- Door handle at standard height, no rotary, knob or shell handle

- At least 120 cm of space in front of the toilet bowl for manoeuvring
- Accessible from the right, **less than 90 cm of space on the side for manoeuvring because the changing table is in the way**

- **Distance between the front edge of the toilet and the rear wall for manoeuvring less than 65 cm**
- **WC height 40 cm** (standard 46–48 cm), **no backrest available**

- Grab rail protrudes at least 15 cm beyond the front edge of the toilet
- Folded-up grab rail protrudes max. 20 cm into the room
- Folding support handle securely attached to the wall, **not easy to operate**

- Flush at standard height (80–110 cm), **not accessible from the toilet while seated**
- Toilet paper accessible from a seated position on the toilet, **but roll not in the folding support handle**

- **No emergency bell available**

- Movement area in front of the washbasin at least 120 x 120 cm, **but less than 150 x 150 cm**
- Top edge and depth of washbasin comply with standard
- **Clear height under the washbasin less than 70 cm**, flat plaster siphon (protected with plastic or porcelain)
- Wheelchair accessible over a width of at least 100 cm
- Touch-free or single-lever tap, distance to the front edge of the washbasin max. 20–35 cm
- **Mirror lower edge at a height of 126 cm** (standard max. 95 cm)
- Operating level of fittings at a height of 80–110 cm
- **Coat hooks at a height of 160 cm** (standard max. 120 cm)
- Waste bins can also be operated with one hand

- Separately located (unisex)
- Toilet door opens outwards and can be unlocked from the outside in an emergency
- Door handle contrasts with adjacent components
- **No emergency bell**
- Fittings do not stand out visually from their surroundings

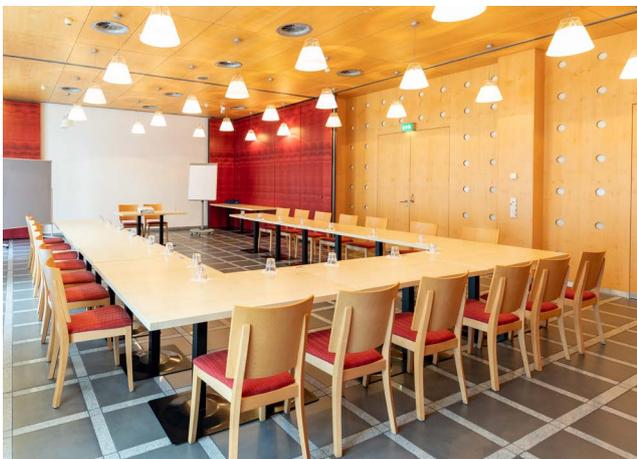
- Accessible via lift without thresholds
- Clear door width of at least 80 cm
- Sufficiently large passage widths and movement areas between furniture
- **No under-table wheelchair access (table edge height 66 cm instead of 70 cm)**
- Counter height max. 85 cm
- Seating options are between 46 and 50 cm high, with stable armrests and backrests, movable
- All controls at a height of 80–110 cm

- **No tactile floor information leading to the room**
- **No attention was paid to room acoustics**
- Seminar room glare-free and evenly lit

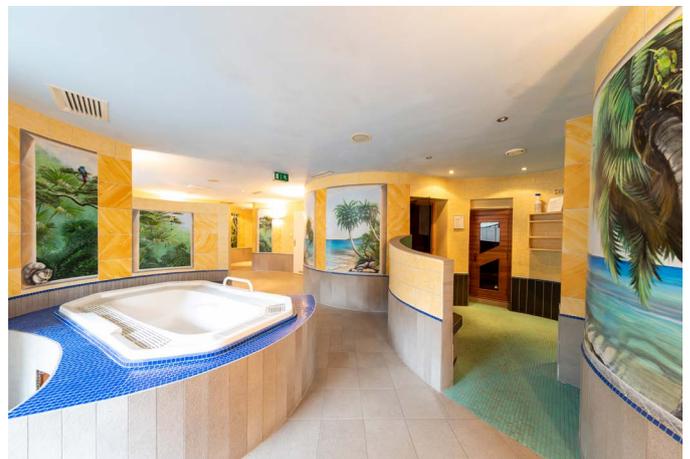
Wellness area

- Whirlpool, Finnish sauna, steam bath, solarium
- Path to the wellness area is step-free and threshold-free, but not very wide (**only 76 cm wide to the saunas**)
