HOTEL DREI RABEN

EVALUATION CRITERIA

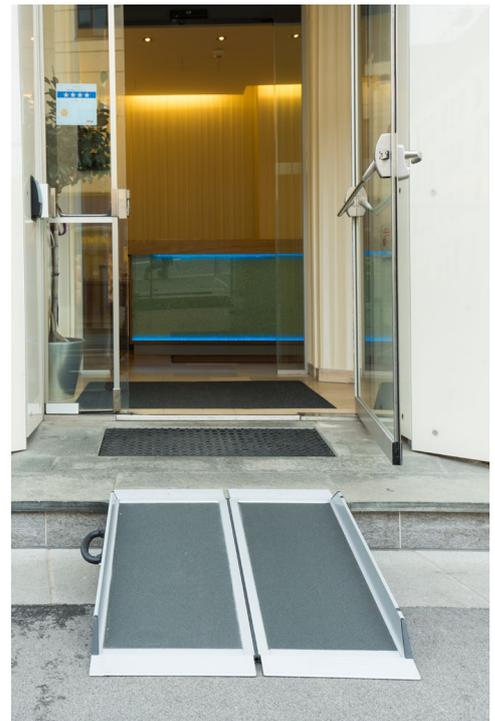
- Access to the entrance is level
- **There is an 11 cm high step at the hotel entrance**
- This can be overcome with a mobile ramp on request (width 80 cm, length 90 cm, **gradient approx. 18%**)
- vestibule with hinged door and sliding glass door (**not marked with sufficient contrast**)
- Door opening side marked
- Movement area of 150 cm diameter only on the inside of the door, **not on the outside (due to step)**
- **Hinged door not easy to open**, door handle at standard height
- On the opening and closing side, there is a lateral approach area of at least 50 cm next to the door handle
- **Door threshold of 2 cm** (only on one side)
- Entrance covered, free of obstacles
- Clear width of entrance doors at least 90 cm
- Doorbell or intercom at standard height
- Grating or dirt-trapping mat easily accessible by wheelchairs

Entrance with mobile ramp

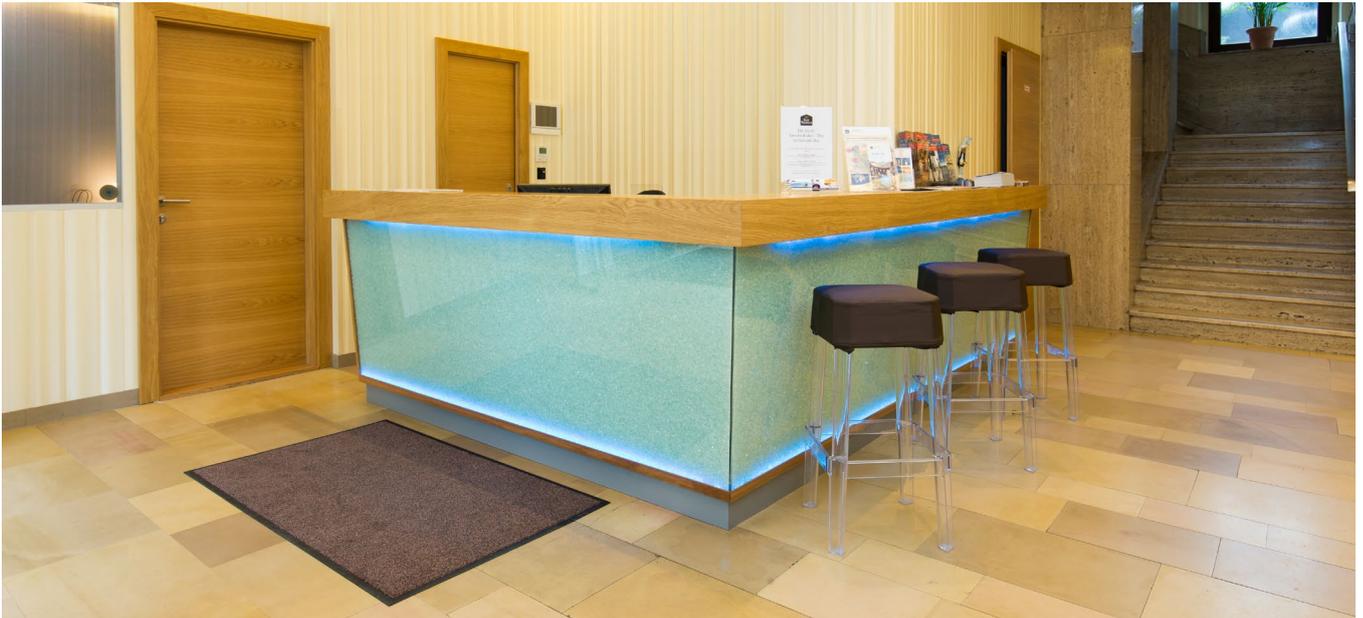
Reception

- Reception/waiting area spacious, no thresholds
- Seating available, with sturdy armrests and backrests, **seat height 41 cm** (standard 46–50 cm)
- Reception: **not accessible and usable for wheelchair users, counter 100 cm high** (standard max. 85 cm), **no under-desk wheelchair access**
- Visual and verbal contact between wheelchair users and reception staff is guaranteed
- In front of the reception counter, movement area of at least 150 x 150 cm
- Passageways at least 90 cm wide
- credit card machine usable at a height of 80–110 cm

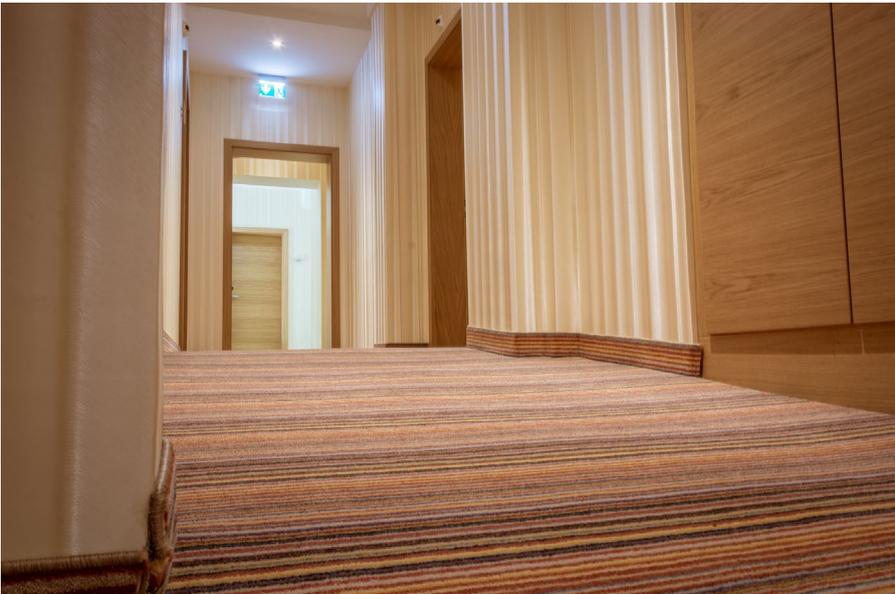
- **12% gradient** (standard max. 6%) to the accessible rooms on the ground floor
- Threshold (3.5 cm high) to rooms on the ground floor and breakfast room is bridged by a small ramp
- Lift available (to the accessible room on the 1st floor)
- Floor coverings are slip-resistant and firmly laid
- Carpets do not pose a tripping hazard
- Paths are at least 120 cm wide, with a turning circle of at least 150 cm in diameter at the end of the path
- Passageways are at least 90 cm wide
- Passage heights of at least 210 cm
- Paths max. 100 m long, seating available along the path
- Consistent signage so that it is easy to find your way around the hotel
- Signage without reflections, font size adapted to reading distance
- **No orientation or escape plan available**
- Barrier-free areas marked with symbols

12% gradient to accessible rooms

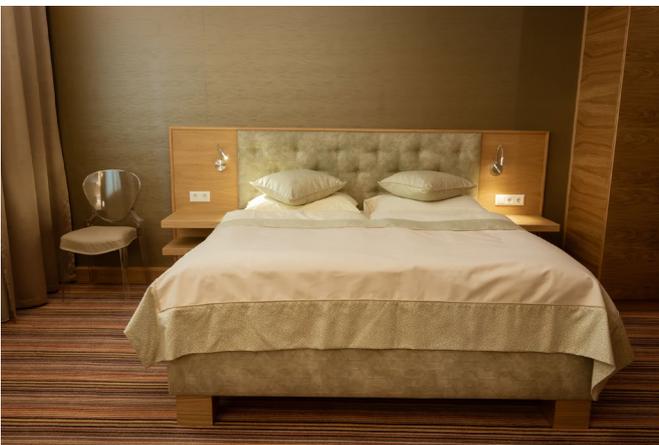
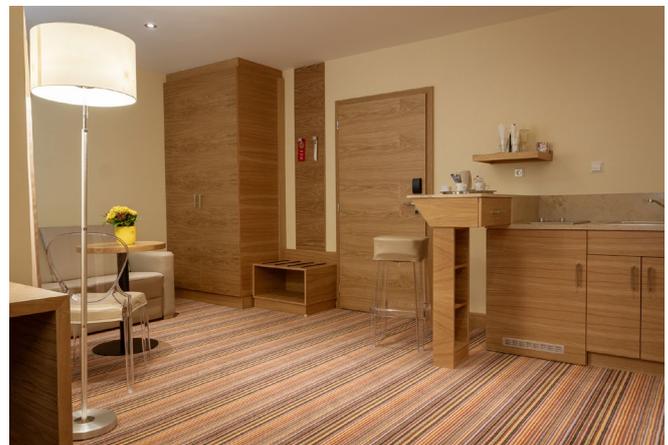
Room no. 001

- Hinged door, clear passage width at least 90 cm, no threshold
- Easy to open, no door closer
- Approach area on the opening side of the door at least 200 x 150 cm
- Approach area on the closing side of the door at least 150 x 120 cm
- On the opening and closing side of the door, there is an approach area of at least 50 cm next to the door handle
- Door handle (no twist, knob or shell handle) at standard height
- **Only 60 cm of space on one side of the bed** (standard min. 150 cm)
- **No under-bed wheelchair access, top edge of bed 57 cm** (standard 45 - 50 cm)
- Light can be switched on from the bed
- Passage widths in the room at least 120 cm
- Light switch at a height of 85–110 cm
- **Coat hooks higher than 120 cm**
- Movement area in front of the window at least 150 x 150 cm, **window handle higher than standard** (max. 110 cm)
- Carpets easily accessible with a wheelchair

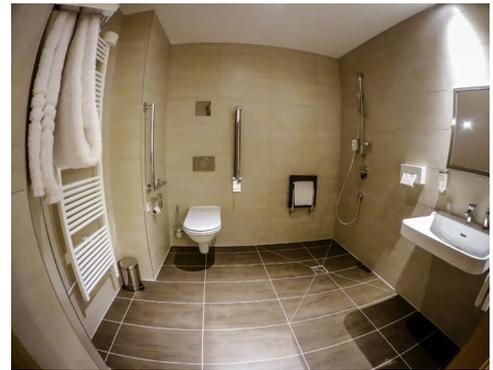
Accessible bathroom

- Shower area without threshold, **100 x 137 cm in size** (standard min. 130 x 180 cm or 150 x 150 cm)
- Floor with anti-slip finish
- No shower enclosure
- **No grab rails in the shower area**
- Fixed folding shower seat, seat smaller than 40 x 40 cm, seat height 50 cm (standard 46–48 cm)
- Also mobile shower seat (stable)
- Height-adjustable hose shower, adjustable height complies with standard (75–150 cm) and is located at the bottom
- Shower fitting designed as a single-lever mixer tap, at a height of 80–110 cm, accessible from the side from a seated position
- **No soap holder**
- **No emergency bell in the shower area**

- At least 120 cm of space in front of the toilet bowl for manoeuvring
- Accessible from the right, with at least 90 cm of space on this side for manoeuvring
- Distance between the front edge of the toilet and the rear wall for manoeuvring: at least 65 cm
- Toilet height 46–48 cm, **no backrest available**
- Horizontal grab rails on both sides, additional vertical grab rail
- Grab rail on the approach side can be folded up, easy to use and securely attached to the wall
- Grab rails at standard height (75–85 cm), distance between grab rails 65–70 cm
- Grab rail protrudes at least 15 cm beyond the front edge of the toilet
- Folded-up grab rail protrudes max. 20 cm into the room

- Flush at standard height, **not accessible from the toilet when seated**
- Toilet paper can be reached while seated on the toilet, but is not located in the folding support handle
- Emergency call system accessible from a seated position on the toilet, **not accessible from the floor at a maximum height of 35 cm**
- Emergency call leads to reception

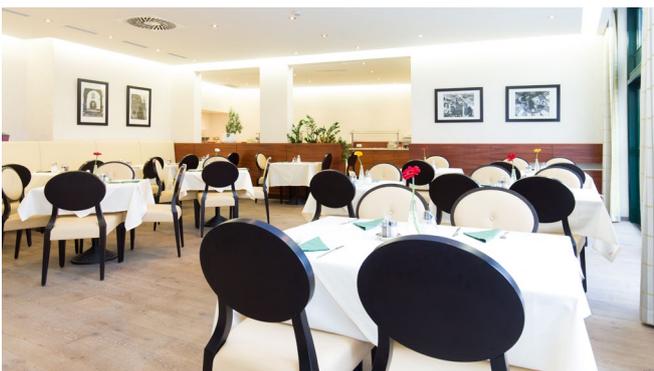
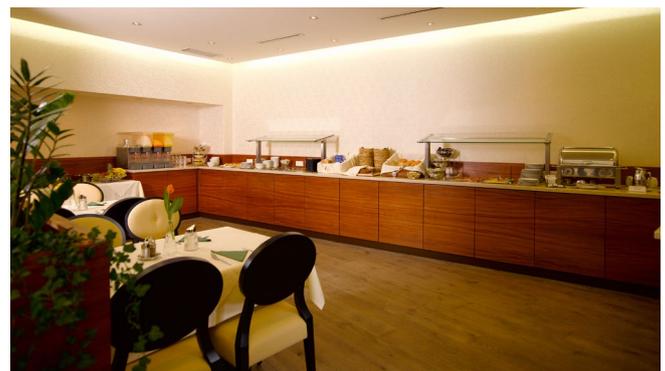
Breakfast room

- 3.5 cm threshold to the breakfast room, bridged by a small ramp
- **No accessible cloakroom available**
- Passage widths of main corridors at least 100 cm, of cross corridors at least 70 cm
- Tables are wheelchair accessible (at least 80 cm wide, 70 cm high, 60 cm deep), table height max. 85 cm
- Tables max. 85 cm high
- High chairs for children available
- Seating 46–50 cm high, with sturdy armrests and backrests
- Breakfast buffet without service
- Clear width of the path next to the buffet at least 120 cm
- Food is within reach at a height of 40–70 cm, with dishes served at a height of 90 cm
- **Drinking straws cannot be provided**

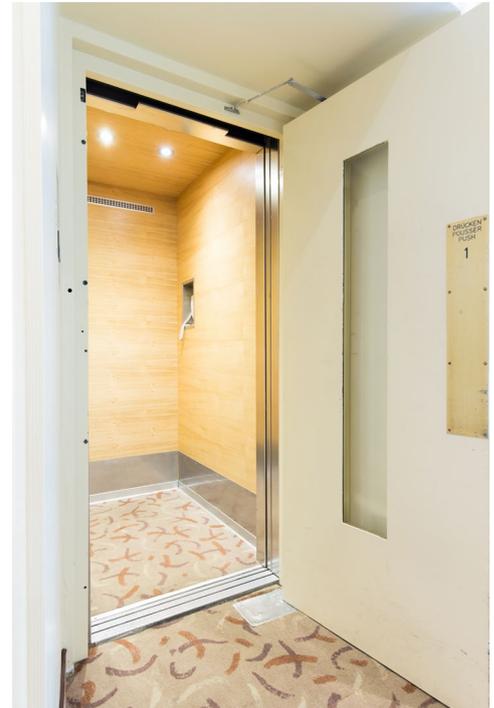
Lift

- Accessible without thresholds
- Movement area in front of entrance and exit at least 150 x 150 cm
- **Clear door width 74 cm** (standard min. 90 cm), no door threshold
- **Door not automatic, difficult to open**
- No stairs leading down opposite the shaft door
- **Lift car size smaller than standard** (minimum 110 x 140 cm)
- Push buttons in close proximity to the lift door
- **No handrail**
- **No mirror opposite the lift door**
- Emergency call button and door control button at standard height
- Position indicator in the lift car at standard height
